Inspection report

Inspection Order	
No. :	
Page No. : 1 of 7	
INSPECTION REPORT	
- Description and Size	quantity
Quantity of Commodity: OMNIA (COMPLETE)	1680 (SET)
- Name & Address Of Buyer: ALEA CONSULTING	
- Name & Address Of factory:	
- Inspection Date 07/01/10	
- P/I No.:	
- Nature Of Inspection:	
Quantity Check Packing Check Marking Check Visual Quality Inspection Dimension Check	
- Inspector: Ing.De Pasquale

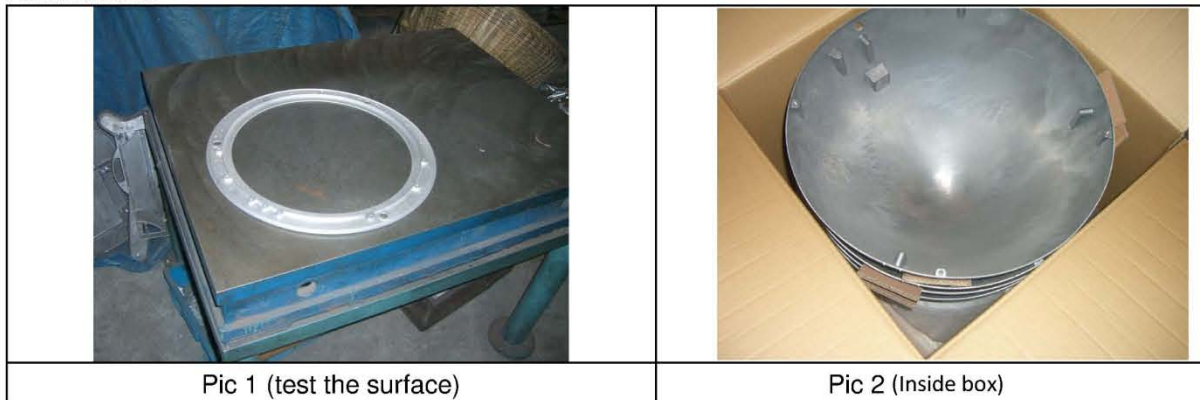
<p>Pic 3</p>	<p>Pic 4 (clean the surface)</p>

Surface: we have not found bave on the surface, the surface is finished through sand blasting we have checked the surface during the production. **inside of the calotta, we found inside without oil. The supplier has cleaned the oil during the production,**

CALOTTA OMNIA	4	PCS	TELAIO OMNIA	4	PCS	CONTROTELAIO OMNIA	4	PCS	 
CALOTTA OMNIA	4	PCS								
TELAIO OMNIA	4	PCS								
CONTROTELAIO OMNIA	4	PCS								
<p>Test screw</p>	<p>the hole should be improved</p>
